Morphological changes of a restored reach: the case of the Spree River, Cottbus, Germany

gerstgraser Ingenieurbüro für Renaturierung (gIR)

Morphological impact of a restoration project: the case of the Spree River, Cottbus, Germany

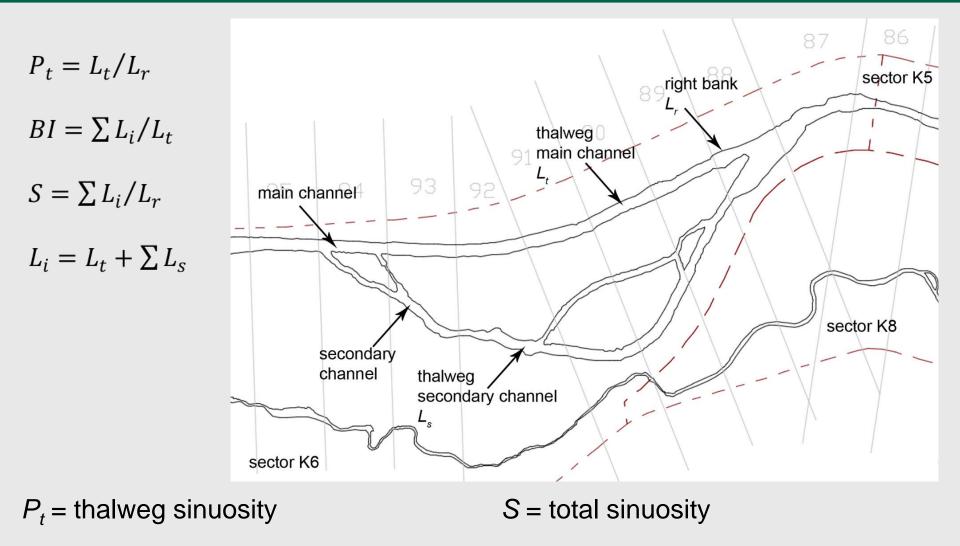
Planimetric variations: comparison of aerial images

BI = braiding index

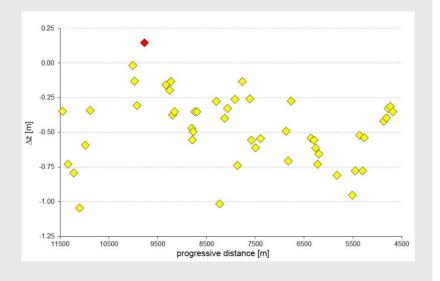
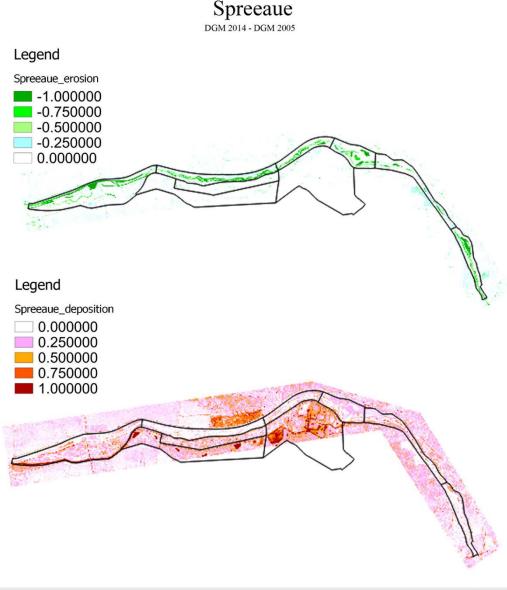
Altimetric variations: comparison of DGMs

Bed erosion

Deposition along floodplains

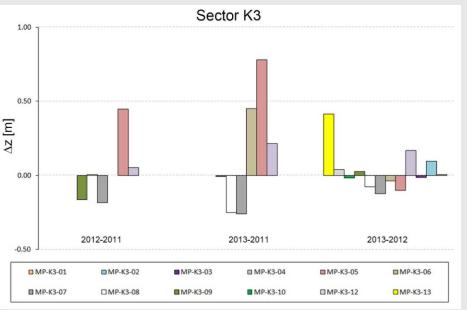
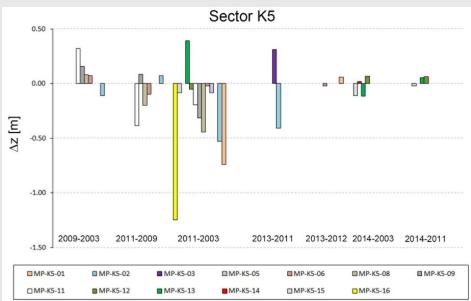
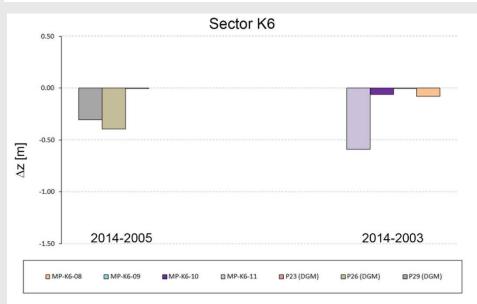
Altimetric variations: comparison of bathymetric surveys

Lack of detailed measurements

Bed erosion visible in the latest surveys
