IMPACT OF RIVER RESTORATION ON HYDROMORPHOLOGICAL PROCESSES: THE FLINTA RIVER CASE STUDY

Tomasz Kałuża, Krzysztof Szoszkiewicz, Artur Radecki-Pawlik,
Natalia Walczak, Karol Plesiński

Department of Water and Sanitary Engineering, Poznan University of Life Sciences,

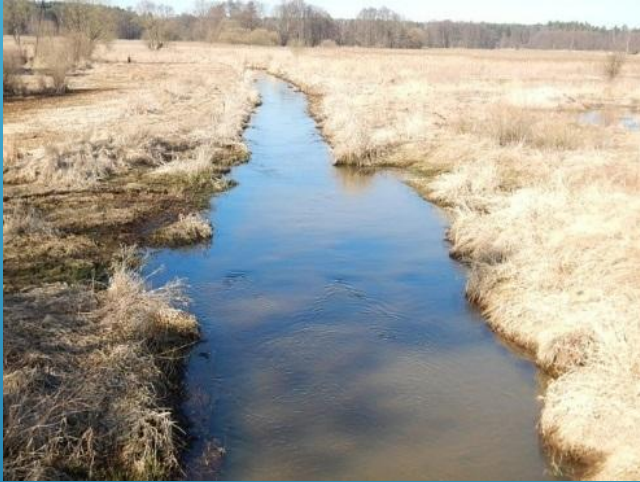
a) location of the study site on the river Flinta near Rożnowo,

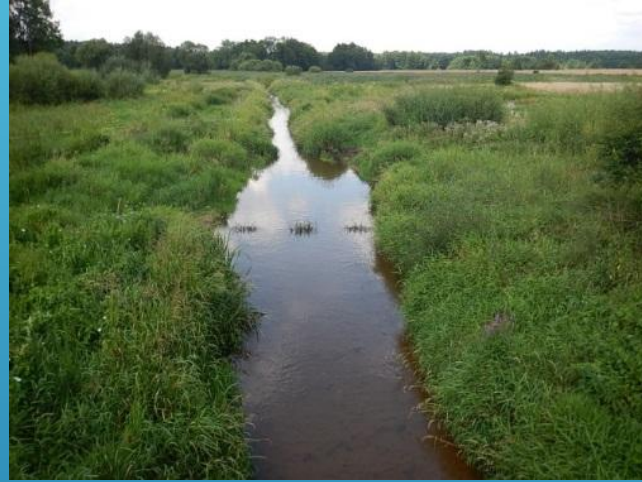
b) the river bed and the sediment traps on 25.09.2013,

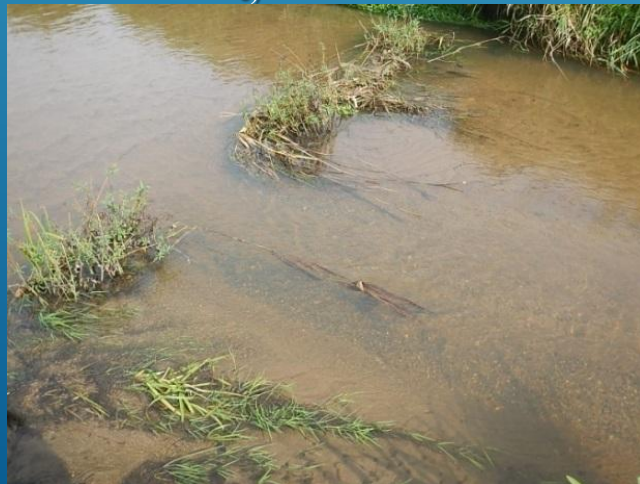
c) the sediment traps with plant debris on 25.09.2013,

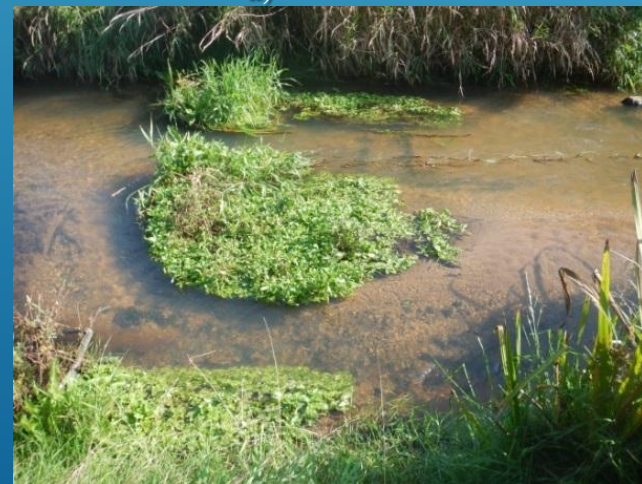
d) the sediment traps with plant debris and plants growing on it on 2.10.2014.

- Plant baskets hydraulic structures (PBHS) change the hydrodynamic conditions and lead to sediment accumulation and formation of river backwaters downstream and upstream the obstacle.

- PBHS cause plant debris accumulation, which influences the hydrodynamic flow conditions.
- The installation of PBHS on the river bed alters the flow conditions. Shear stress is an example of an affected hydraulic parameter – its value before the vegetative sediment traps increased significantly from $\tau = 0.027 \text{ N} \cdot \text{m}^{-2}$ (2.08.2013) to $\tau = 0.465 \text{ N} \cdot \text{m}^{-2}$ (2.10.2014)

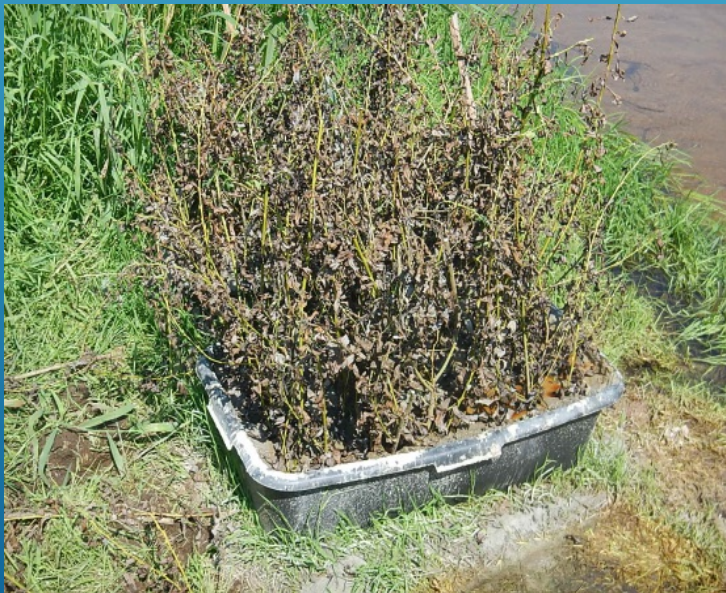
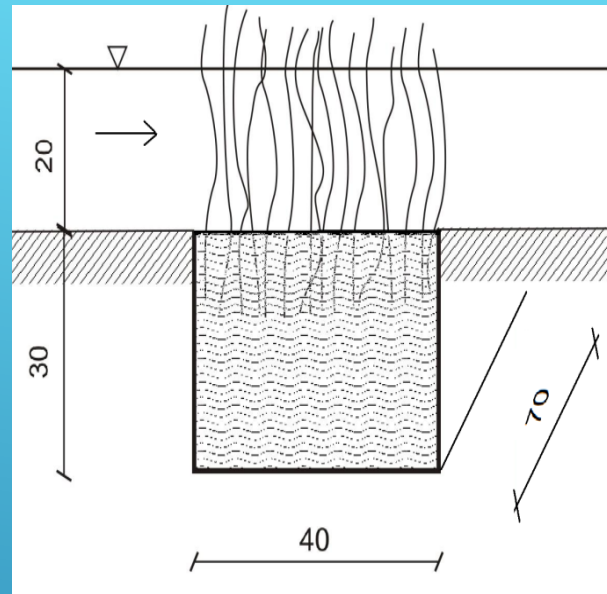
Dimensions and
sketch of PBHS

Plant basket hydraulic structures (PBHS): a) just constructed at the river bank, b) just immersed in

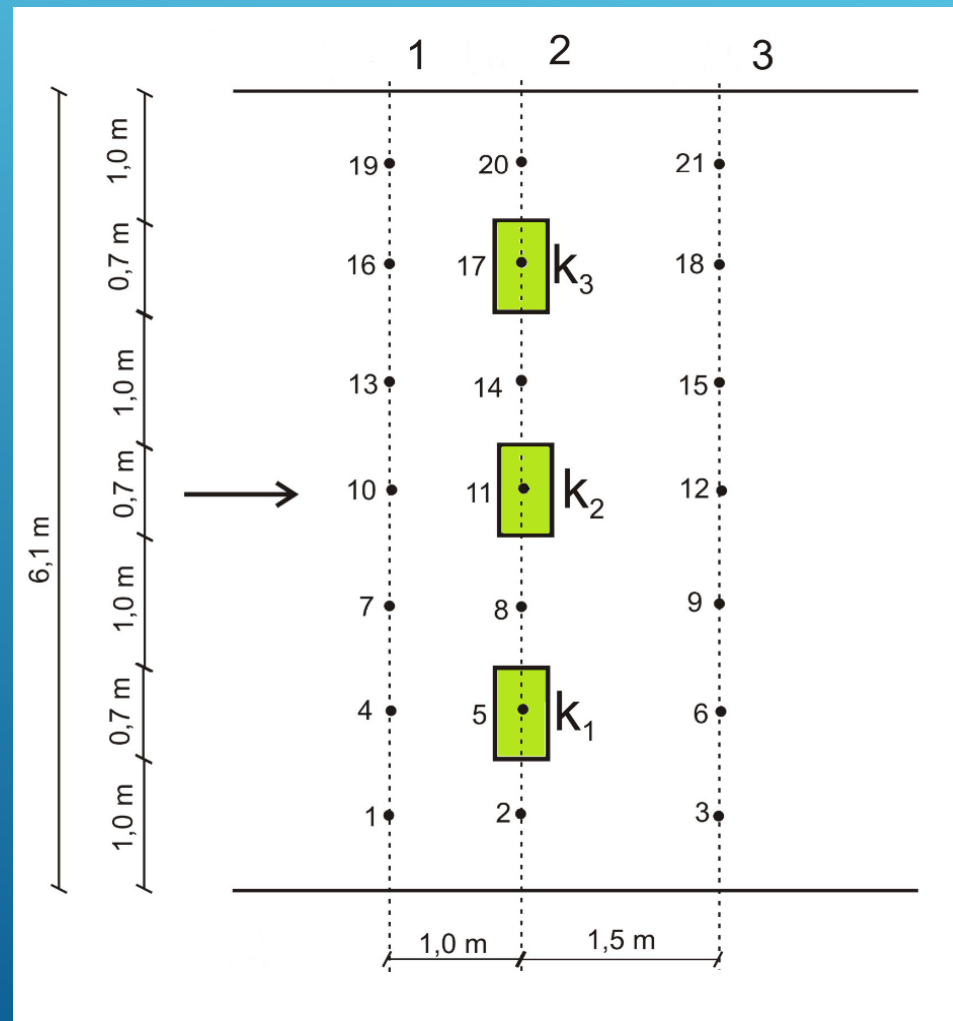
INVESTIGATED (PBHS) AND THE MEASURING POINTS ALONG THE FLINTA IN THE CASE STUDY RESEARCH REACH

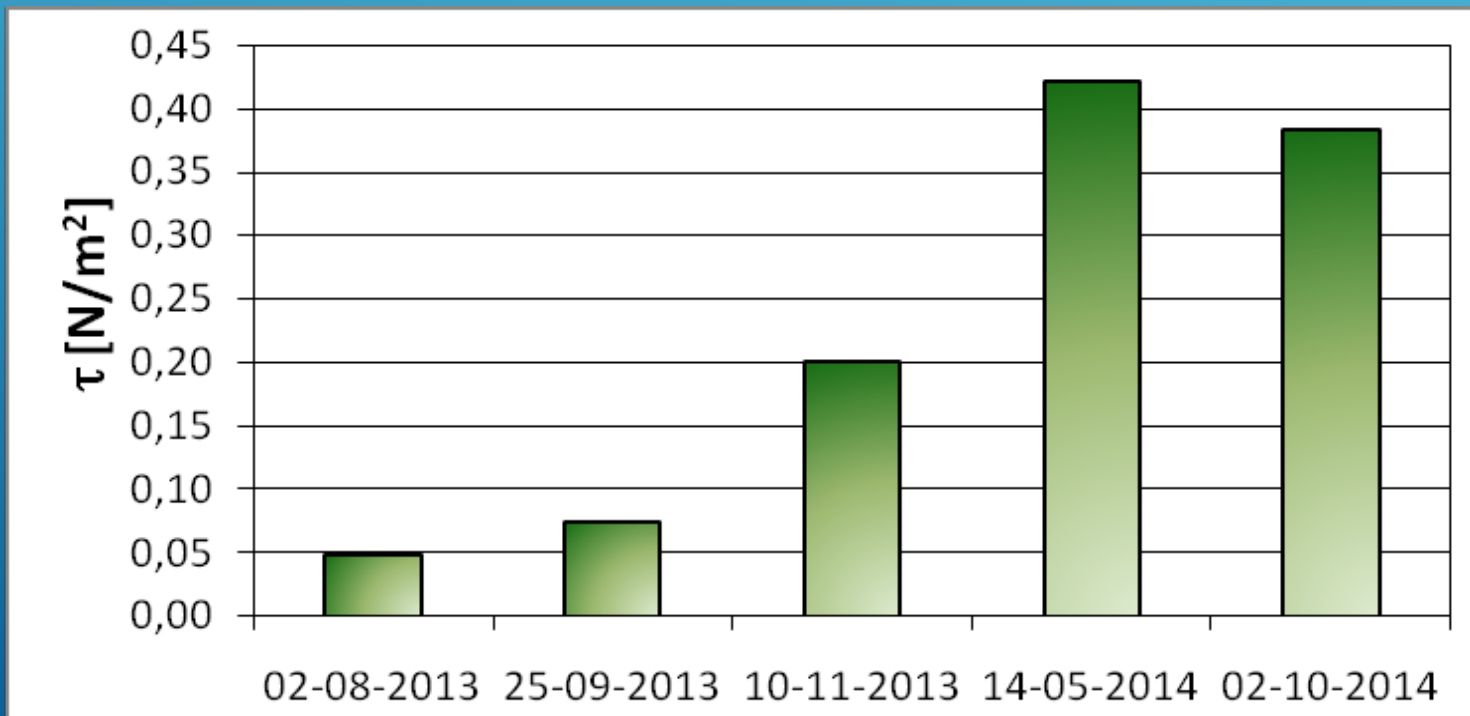
AVERAGE SHEAR STRESS BEFORE AND AFTER THE INSTALLATION OF PBHS OVER THE TIME UNDER STUDY
