International School of Hydraulics

23 - 26 May 2017 • Jachranka • Poland

NATURAL AND ANTHROPOGENIC CHANGES OF THE VISTULA OUTLET TO THE SEA

WOJCIECH MAJEWSKI

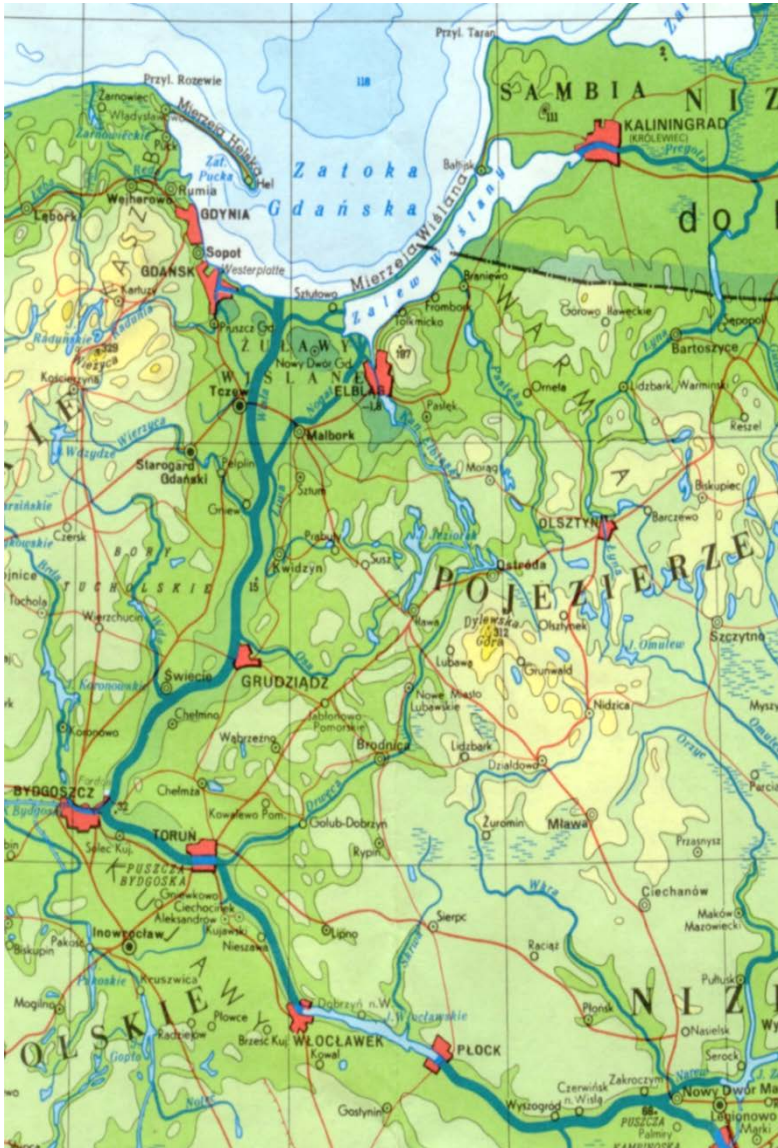
THE LOWER VISTULA

- Section 391 km long, river basin $41 \cdot 10^3 \text{ km}^2$
- Very important for energy and navigation
- Part of this section was trained for navigation, the Pomorska Vistula
- Bydgoszcz Channel and Bydgoszcz Water Node
- Important cities and industrial centers
- Hydraulic Project Wloclawek with run-of-river reservoir (1970), whole section under Natura 2000
- Section ice jam prone, numerous floods caused by ice jams
- At the mouth very important area Żuławy,

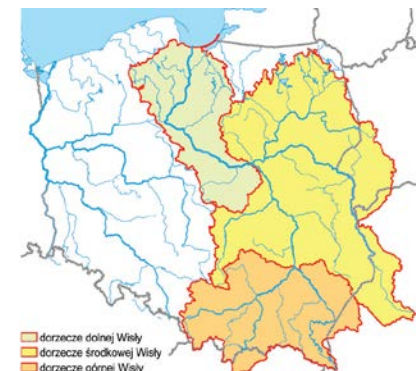
ŻUŁAWY THE DELTA OF VISTULA

- Żuławki Wiślane have the area 1700 km²
- Żuławki have 3 distinct parts: Żuławki Gdańskie, Malborskie, Elbląskie
- The main hazards: from the main Vistula channel, from wind upwellings in the Bay of Gdańsk and in Wiślany Gulf, and local floods
- Żuławki create a very important area from economic, social and ecological point of view
- Present safe operation of Żuławki is due to implementation of Direct Channel (Przekop) in 1895.

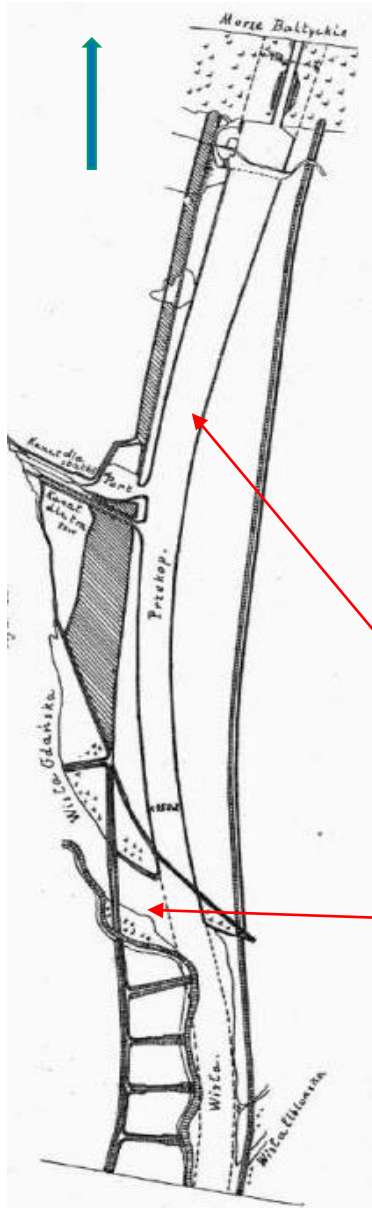
- In XIX century several proposals to solve this problem were prepared
- In 1877 the design of Arsen and Fahl seemed to be very good as it solved many hydraulic problems of this area in a comprehensive way
- This project proposed Direct Channel from Przegalina to the Bay of Gdańsk
- Direct Channel was 7.1 km long, widths 250 – 400 m with flood dykes on both sides and fascine lining. The crest of flood dykes was 7.5 to 8.5 m above average sea level
- Bottom of the channel was 1.3 – 1.8 m below average sea level
- Project included also river training of Pomorska Vistula and construction of new hydraulic structures
- Final section of the channel 1.4 km long, going through the dunes was only 50 m wide
- Company, which just completed Kiel Channel was commissioned for this project

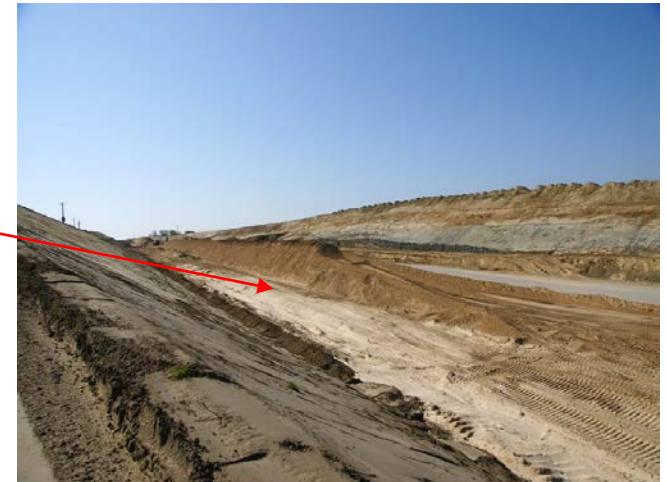
OPENING OF THE DIRECT CHANNEL

- In 1894 all earth works were completed. Total earth volume was 7 mil. m³
- The main part of the channel was filled with water and the channel was ready for opening.
- Opening was realized on the 31 March 1895 by the President of East Prusia on behalf of Ceaser Wihelm II.

- After 45 min. the channel width increased to 100 m, after 3h 200 m and after 16 h to 300 m.
- During 16 h. 2 mil. m³ of soil were transported to the sea.
- After spring season the proper dimensions of the channel were achieved with the consequence of transporting 9 mil. m³ of sediments
